Performance of Precast Concrete Stay-in-Place Forming System for Lock Walls Rehabilitation

by James E. McDonald and Robert R. Bottin, Jr.

PURPOSE: The Hydraulic Engineering Technical Note (HETN) herein provides an assessment of the performance of precast concrete lock wall panels at Allegheny River, Lock and Dam No. 4. Design and construction methods used in the rehabilitation are applicable to other lock projects within the U.S. Army Corps of Engineers' areas of operation.

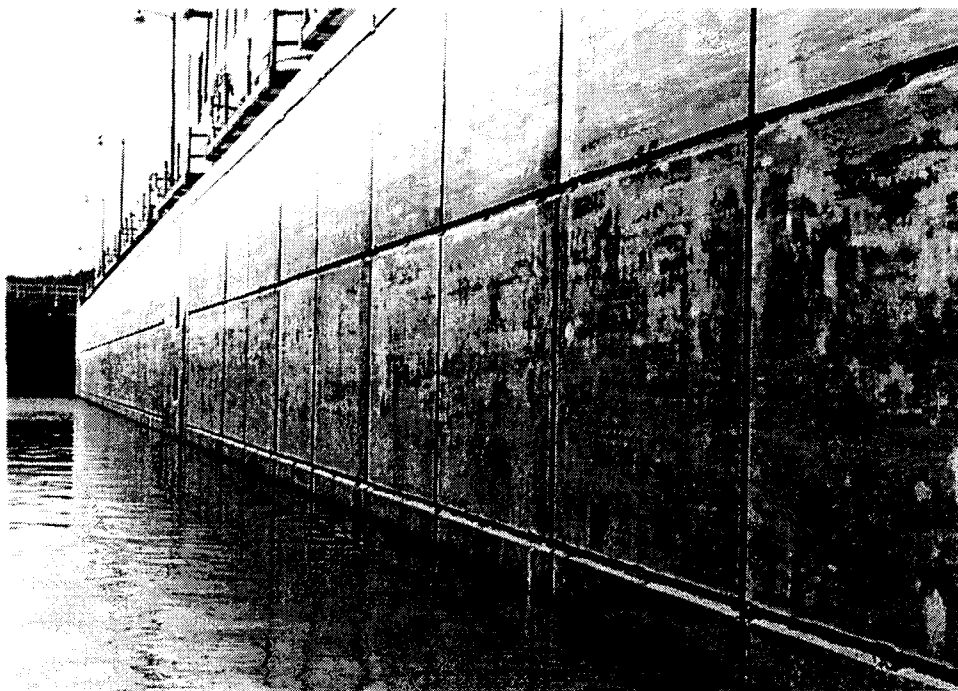
Figure 2. Precast lock wall panels

Cracking: Cracking in one precast panel out of the total of 93 was observed prior to panel installation. Two hairline cracks starting at the top upstream half of the panel and traversing the face to the center portion of the panel were reported. Similar cracks were observed in the top panel at the upstream end of the river wall following placement of the infill concrete. These cracks were attributed to inadequate shimming during panel installation. Cracks previously reported appeared to be partially healed with a maximum crack width of 0.02 cm (0.008 in.). With the exception of hairline cracks at a few control joints, no additional cracks in the precast concrete were found during the inspection. It was noted that at least one crack was observed in each monolith resurfaced with cast-in-place concrete. Typical crack widths were larger than those in the precast concrete, ranging from 0.02 to 0.04 cm (0.007 to 0.016 in.).

Deterioration: The precast concrete appeared to be in very good condition relative to deterioration, although some localized spalling along joints was observed. Several precast panels in the upper row on the river wall exhibited what appeared to be superficial surface crazing, although there was some question whether the crazing was in the concrete or some deposit on the concrete surface. Cast-in-place concrete surfaces, on the other hand, exhibited extensive bugholes.

Vertical Joints: Tapering the ends of the precast panels to create a recessed joint between adjacent panels appeared to eliminate barge impact on the edges of the panels. Only one panel on the land wall had localized cracking and incipient spalling that was obviously the result of barge impacts within the tapered area. Hairline cracks were observed in a few control joints that would indicate they are effective in controlling cracking. Joints between the precast panels and cast-in-place concrete were not tapered, and thus, exhibited more spalling because of barge impact.

Horizontal Joints: Both walls exhibited localized concrete spalling along the horizontal joints between panels. Joint spalls on the land wall were concentrated along the bottoms of the panels in the upper two rows. Similar conditions were observed on the river wall, except the spalls appeared to be concentrated along the tops of the panels. These conditions may be attributed in part to traffic patterns at the lock. Downbound and upbound traffic reportedly rubs against the land and river walls, respectively. Emptying and filling of the lock chamber under these conditions would tend to cause tensile stresses along the bottom and top edges of panels on the land and river walls, respectively.

Joint Leakage: Minimal joint leakage was observed during the inspection. Observations revealed only minor leakage concentrated along the horizontal joint between the middle and bottom rows of panels in each wall.

CONCLUSIONS AND RECOMMENDATIONS: Overall, the precast concrete lock wall panels appeared to be in very good condition, although there was some localized spalling along the joints. The condition of the lock walls should be monitored periodically in the future to establish the long-term durability of precast concrete as a stay-in-place forming system for lock wall rehabilitation. Discontinuities in lock walls created by joints are usually the areas that are most vulnerable to impact by barges. This attribute was noted for the cast-in-place joints as well. A study to develop an optimum configuration for horizontal and vertical joints that would minimize barge impact in these areas may be warranted as well as an investigation of potential applications of materials with improved impact resistance, such as fiber-reinforced composites.
